ROAD SAFETY INSPECTION

Wingebellup Road and Poison Hill Road Intersection

Inspection Ref: PTS/RSB/RSI/PS/2023/009

Shire of Cranbrook

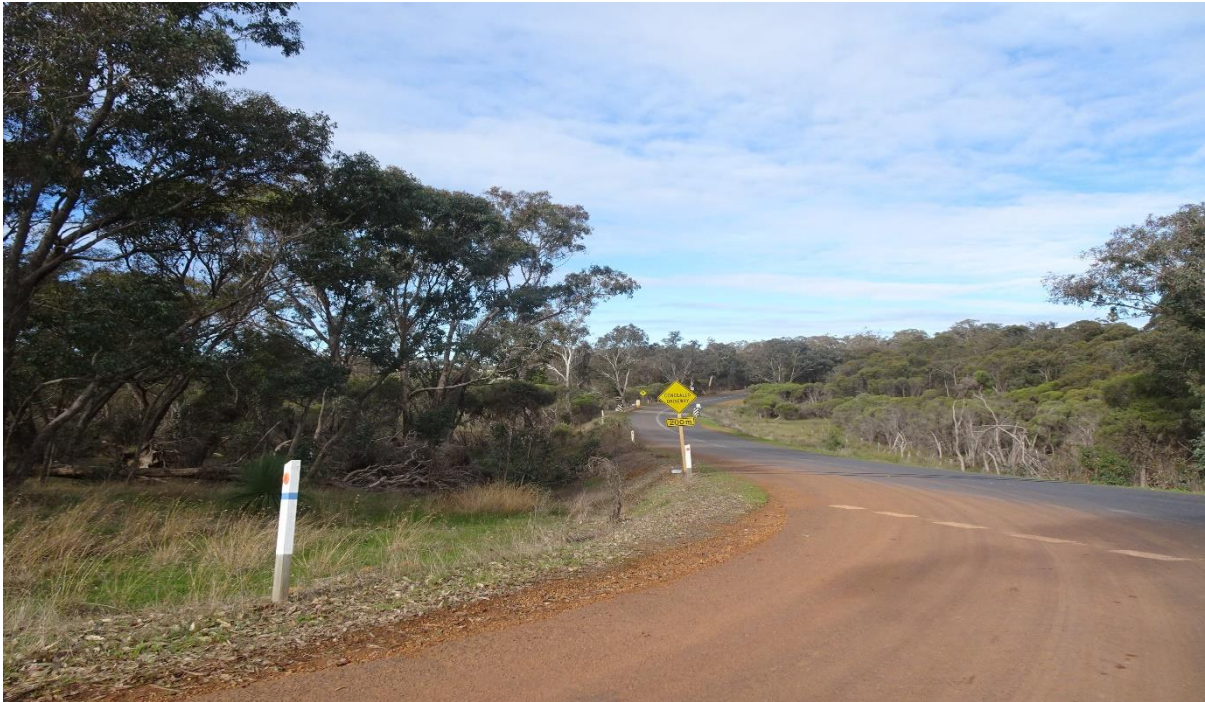
A Concealed Driveway advisory sign situated to the east of the intersection of Poison Hill Road partially obscures sight distance for drivers entering Wingebellup Rd.

There is a risk of vehicles failing to give way whilst exiting the intersection which could result in right angle crashes.

A Concealed Driveway ahead advisory sign located on the northern verge east of the intersection on Poison Hill Road partially restricts sightlines to 45 m for vehicles entering Wingebellup Road.

Austrorads Guide to Road Design Part 4A: Unsignalised and Signalised Intersections indicates that Safe Intersection Sight Distance is the minimum distance which should be provided on the major road at any intersection. Using an operating speed of 60 km/h and reaction time of 2.0 seconds the required Safe Intersection Sight Distance is 123 m measured 7.0 m back from the conflict point on the side road.

3.1 Finding 2.1 – Insufficient Safe Intersection Sight Distance Wingebellup Road for traffic entering from Poison Hill Road.

The Concealed Driveway sign should be relocated or removed if no longer required to provide adequate Safe Intersection Sight Distance in accordance with Austrorads Guidelines.

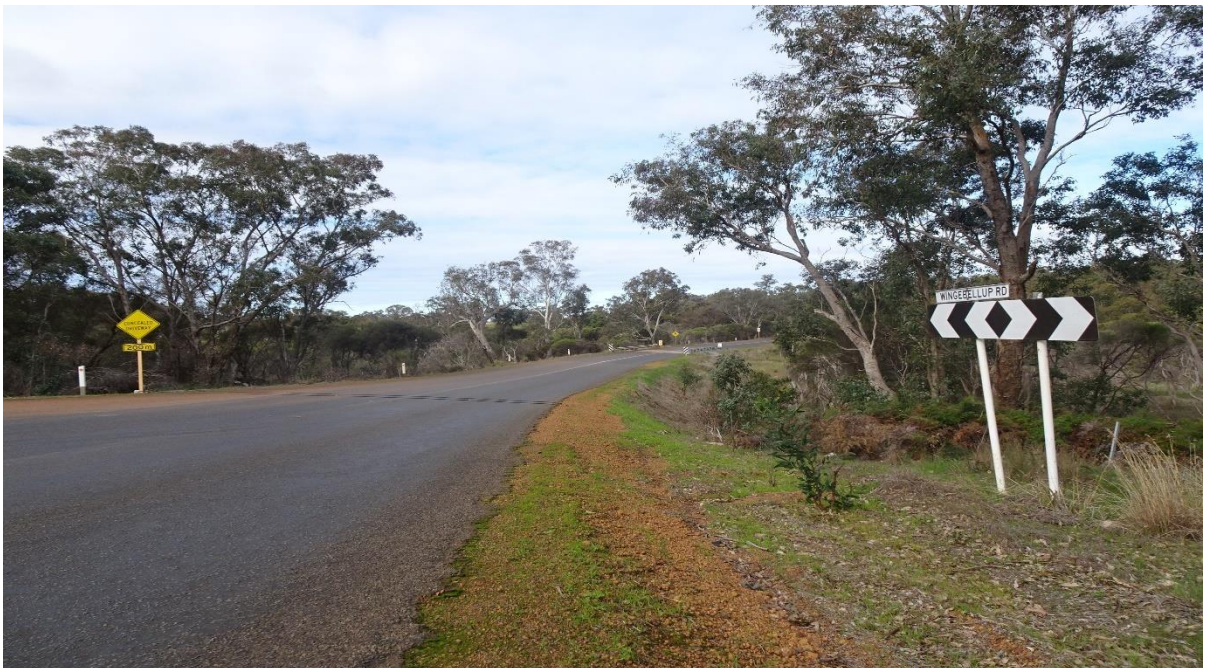
There are insufficient guide posts on the southern verge of Wingebellup Road throughout the curve between Booka Street and Poison Hill Road to provide sufficient delineation, particularly for night time.

There is a risk that drivers may not react to the curve due to lack of visual clues as to the road geometry especially at night resulting in run off road type crashes

Guide posts are non existent on the approach or throughout the curve on the southern verge to adequately delineate the inside of the curve.

Australian Standard 1742.2-2009: Traffic Control Devices for General Use indicates for curved sections with 300 – 399 m radius, guide posts should be spaced at 20 m on the outside and 40 m on the inside throughout the curve.

Finding 2.2 – Insufficient Guide Posts Wingebellup Road

Guide posts should be installed through the curve in accordance with Australian Standards.

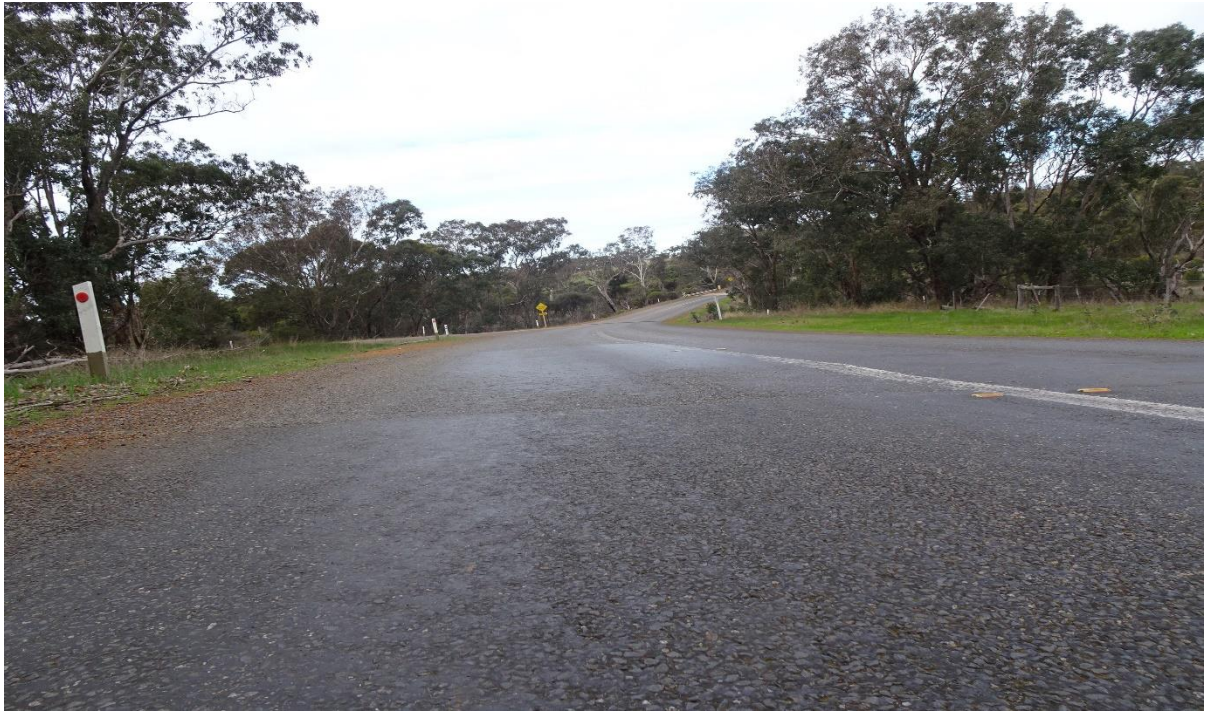
The road surface between Poison Hill Road on Wingebellup Road and 80m to the west on both carriageways has surface flushing and polishing.

There is a risk that drivers could lose control whilst negotiating the curve on the approach to Poison Hill Road resulting in a run off road or right angle crash as a result of reduced braking performance especially in wet conditions.

Worn pavement can lead to reduced skid resistance, thereby causing loss of traction and affect braking performance, particularly on curved sections during wet conditions.

Finding 2.3 – Flushing and Polishing of the Road Surface

The road surface should be repaired to eliminate flushing and polishing in accordance with Austroads guidelines.

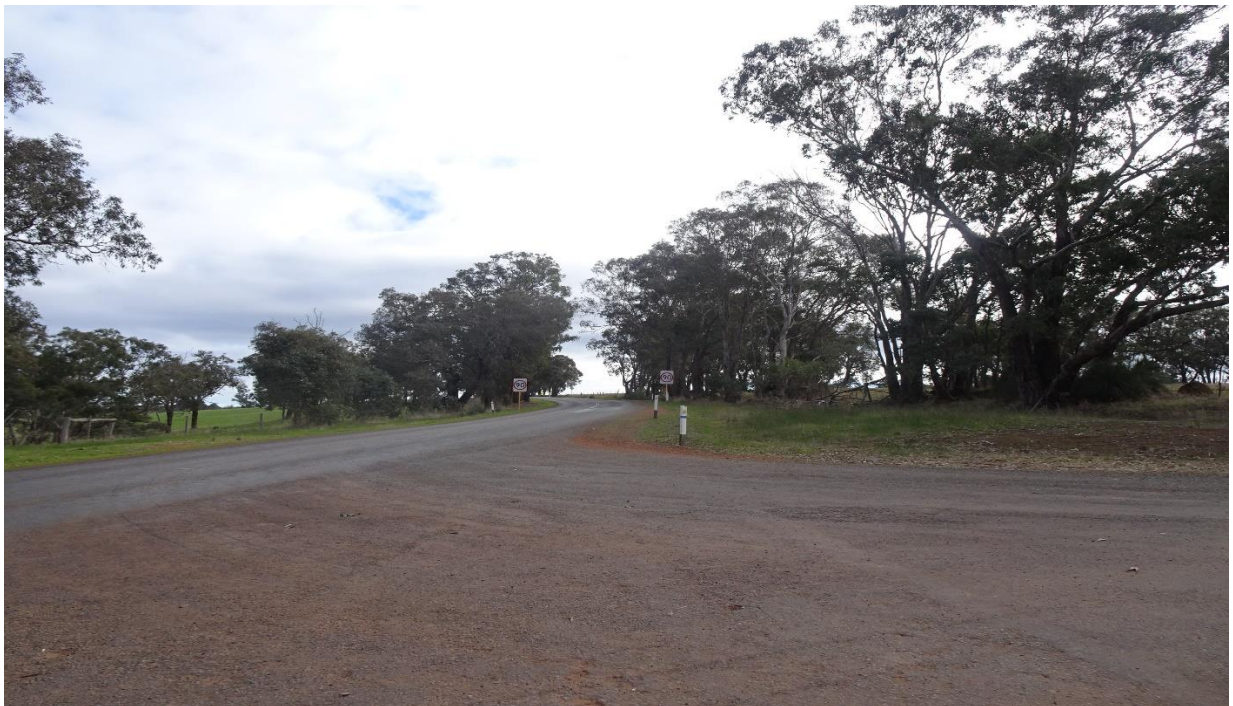
The speed limit on Wingebellup Road changes from 90km/h to 60km/h approximately 50m west of the intersection of Poison Hill Road. This speed change occurs within a 350m radius curve.

There is a risk that drivers may not observe or immediately comply with the lower speed environment resulting in high-speed right angle crashes involving vehicles travelling from the west on Wingebellup Road with vehicles exiting from Poison Hill Road.

There is a further risk that drivers may lose control due to combination of braking and negotiating the curve as they are travelling downhill and especially in wet conditions resulting in run off road type crashes

Australian Standard 1742.4-2008: Speed Controls indicates a change from a lower to a higher zoned speed limit should be avoided in advance of a section of low-speed value alignment. The lower limit should be carried through or past the section.

Finding 2.4 – Speed Limit change within the curve

The existing 60km/h speed zone should be extended approximately 250m further to the west to provide adequate distance prior to the curve and intersecting road in accordance with Australian Standards.

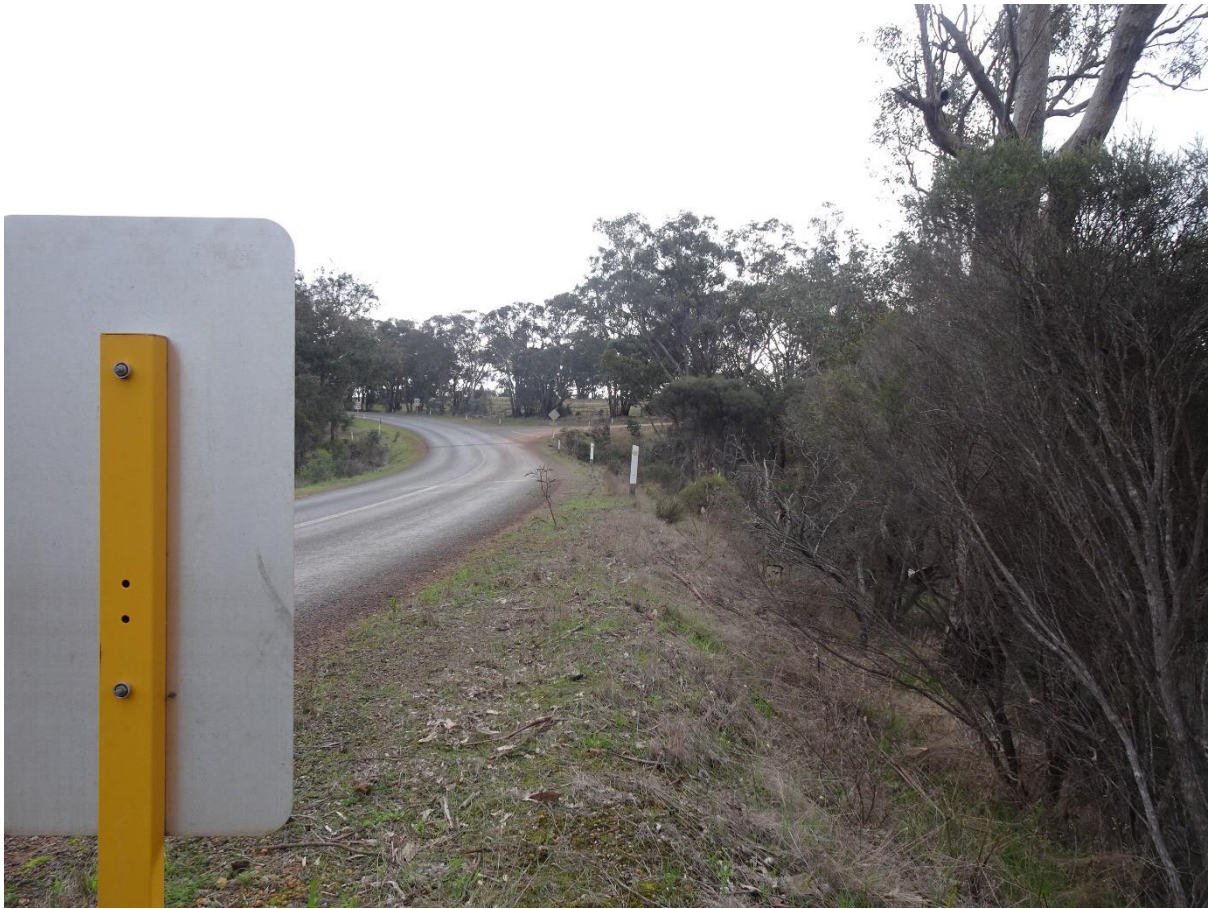
A steep unprotected embankment with a batter slope of 3:1 is located to the east of the intersection of Wingebellup and Poison Hill Road.

There is a risk that an errant vehicle may leave the travel way and travel down the embankment and rollover or hit trees located at the bottom of the embankment.

Austroads Guide to Road Design Part 6 (2018): Roadside Design, Safety and Barriers indicate fill batters greater than 1.0 m in height and steeper grade than 3:1 require a treatment to protect errant vehicles. Treatment of the hazard through flattening of batters where practical or protection by safety barriers should be evaluated.

Finding 2.5 - Non recoverable embankment located on outside of curve

Suitable protection for errant vehicles should be provided in accordance with Austroads guidelines.

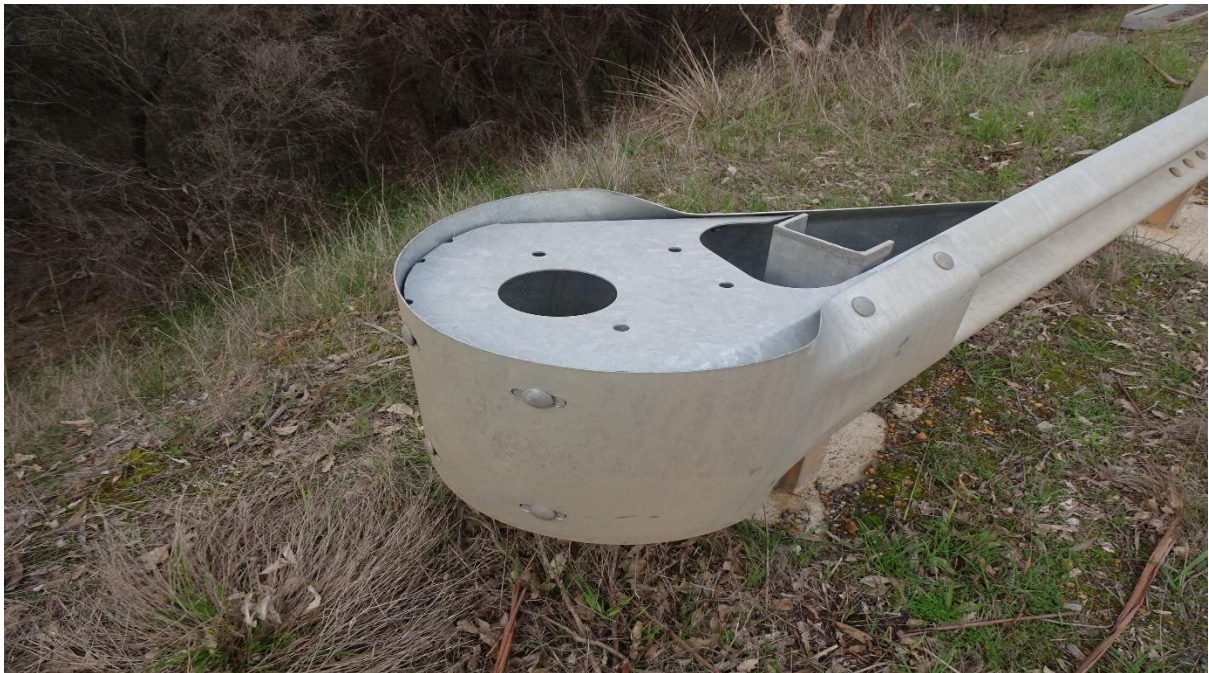
The leading and trailing ends of the crash barrier situated on Wingebellup Road across the Franklin River Bridge have non-crashworthy barrier terminals installed.

There is a risk that when vehicles collide with non-crashworthy barrier terminals the barrier may penetrate the occupant space, or the vehicle may be launched and rollover which can have serious consequences for vehicle occupants.

Austroads Guide to Road Design Part 6 (2018): Roadside Design, Safety and Barriers indicates that once a barrier has been located longitudinally and laterally to accommodate dynamic deflection and sight distance, suitable leading and trailing terminal treatments must be selected.

Finding 2.6 – Non-Crashworthy barrier terminals

Crashworthy barrier terminals should be installed in accordance with Austroads guidelines.
