# ROAD SAFETY INSPECTION

## **Yeriminup Road / Ballochmyle Road (Skewed) Intersection Cranbrook**

**Inspection Ref: PTS/RSB/RSI/PS/ 2023/010**

Report Issue Date: **6/07/2023**

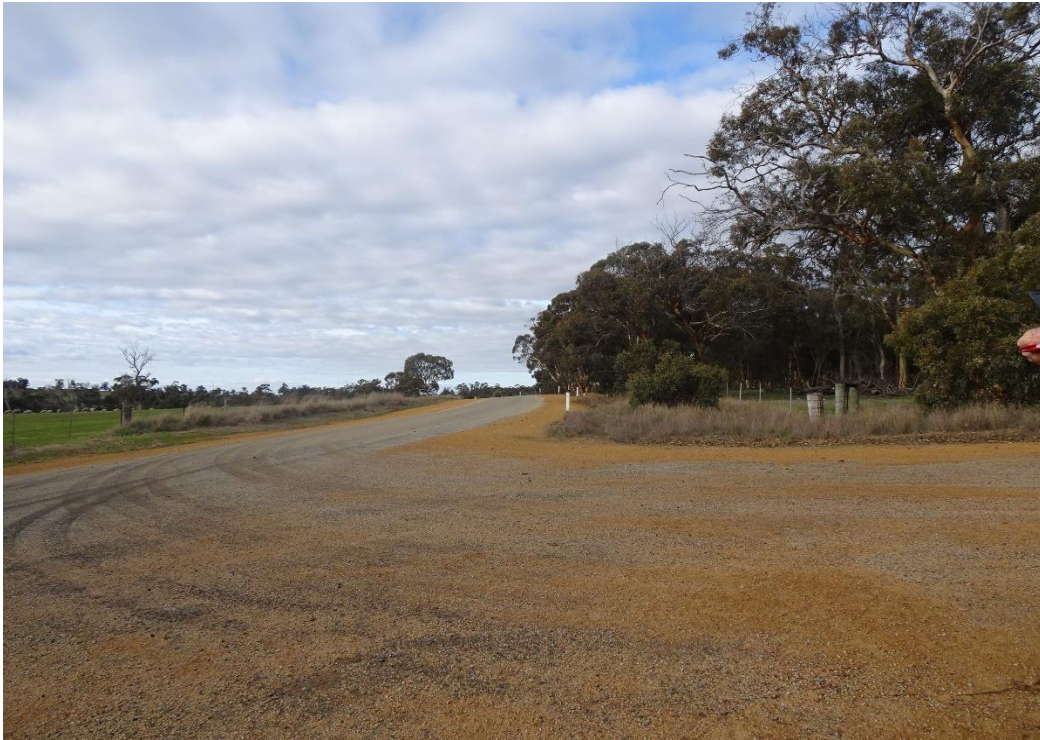
The curve and crest on Ballochmyle Road to the east of the intersection of Yeriminup Road obscures the available sight distance for vehicles travelling on Yeriminup Road.

There is a risk that vehicles travelling on Yeriminup Road may fail to observe vehicles travelling on Ballochmyle Road resulting in right angle or right turn through type crashes. This risk is further increased due to the potential for drivers on Ballochmyle Road failing to give way because of unclear intersection priority.

Available intersection sight distance from the intersection of Yeriminup Road was measured at 190m. *Austroads Guide to Road Design Part 4A: Unsignalised and Signalised Intersection* indicates that Safe Intersection Sight Distance is the minimum distance which should be provided on the major road at any intersection. Using an operating speed of 110 km/h and reaction time of 2.0 seconds the required Safe Intersection Sight Distance is 285 m measured 7 m back along the side road from the conflict point.

**Finding 2.1 – Insufficient Safe Intersection Sight Distance**

If the intersection remains in its current configuration, the crest should be trimmed to a level that provides adequate Safe Intersection Sight Distance in accordance with Austroads Guidelines

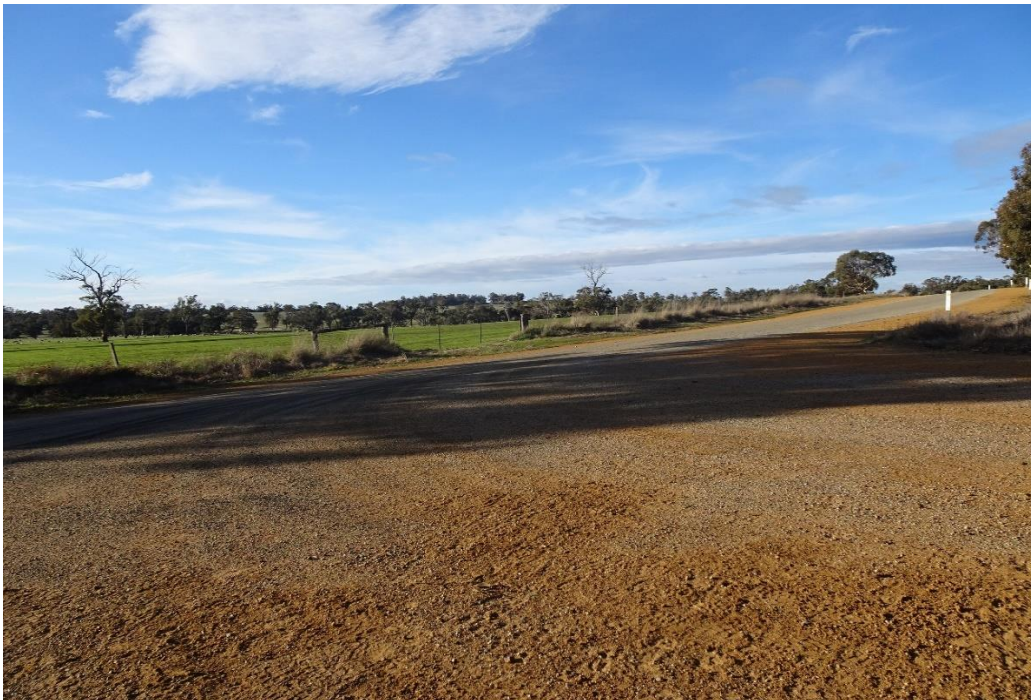
The existing intersection has confusing priority in relation to which road continues and which is considered the terminating leg.

There is a risk that drivers on Ballochmyle Road may fail to give way to entering or oncoming vehicles travelling on Yeriminup Road due to the give way provision being unclear with the continuing road (Yeriminup Road) effectively crossing the terminating road (Ballochmyle Road).

There is no advisory or regulatory signage on any of the approaches to the intersection to advise drivers of the intersection structure or to guide them in deciding who must give way in the case of multiple vehicles approaching at the same time.

**Finding 2.2 Unclear intersection priority**

The intersection should be modified and defined to denote that Yeriminup Road is the continuing road with Ballochmyle Road being the terminating. This modification should include clear line marking and delineation to separate traffic effectively whilst negotiating the curve. Yeriminup Road should be sealed for approximately 100 -150m south east of Ballochmyle Road to provide adequate line marking and advisory speed reduction signage on the approach to the curve. Trees located on the north eastern verge of Yeriminup Road should be removed to provide adequate sight lines for traffic entering Yeriminup Road from Ballochmyle Road.

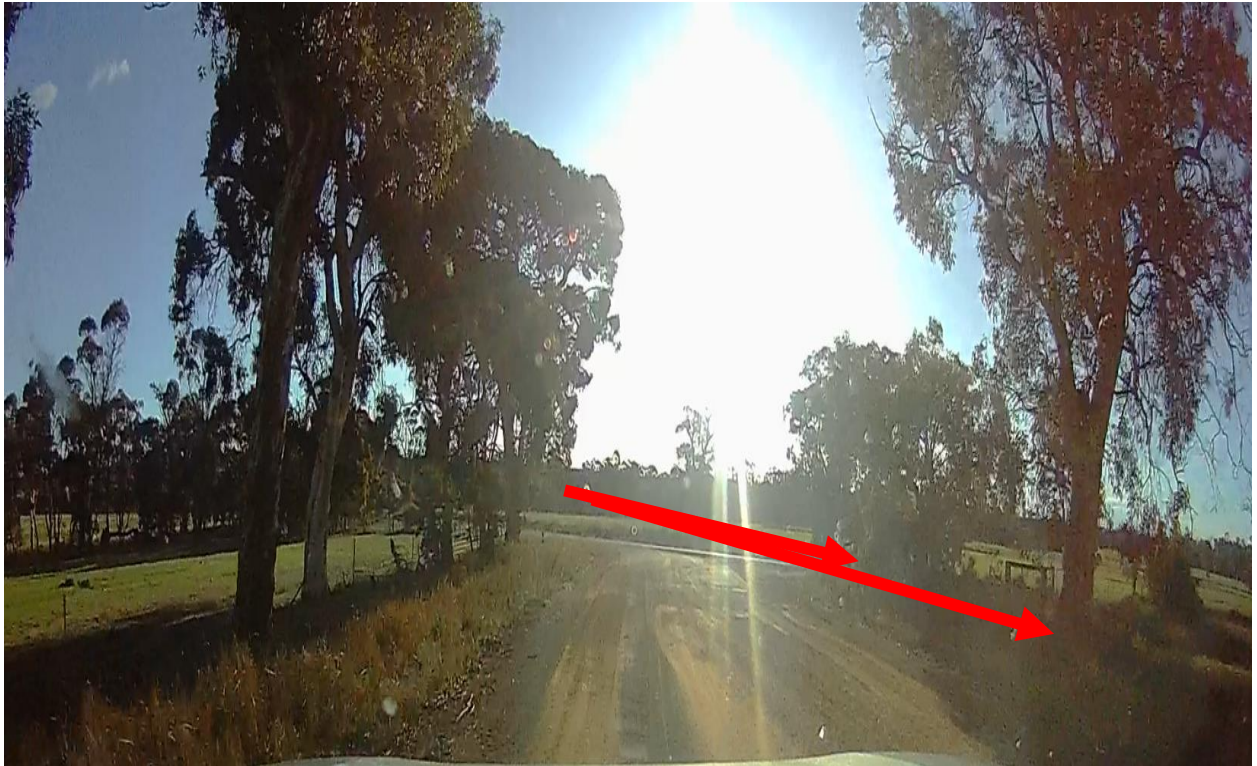
There are two trees with a trunk diameter in excess of 100mm located on the north eastern side of the curve on Yeriminup Road situated within the clear zone.

These trees were measured to be 3 and 3.5m from the travel path.

There is a risk that vehicles may fail to negotiate the bend when travelling from the west resulting in a run off road hit object crash.

Hazards within the clear zone should be removed or suitably protected or be frangible to the impact of a vehicle. Main Roads determines effective clear zones using the Austroads method described in *Austroads Guide to Road Design Part 6 (2018): Roadside Design, Safety and Barriers*. Using a design speed of 110 km/h, <750 vehicles per day, batter slopes of 6.1 to flat and curve radius of 150 m, the required clear zone is 9 m on the outside of the curve.

**Finding 2.5 Trees within the Clearzone**

Trees within the clear zone should be removed or protected from errant vehicles in accordance with Austroads Guidelines.

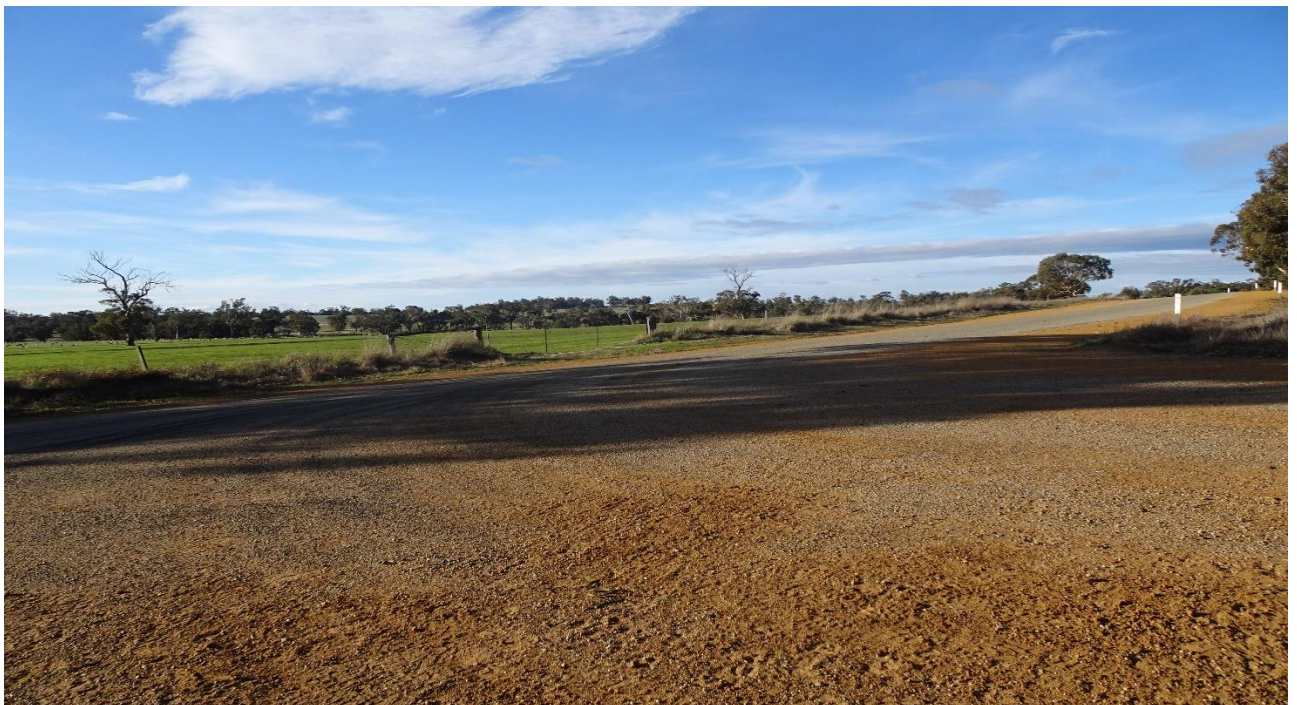
The road surface at the intersection of Yeriminup Road is predominately unsealed resulting in loose aggregate being dragged onto the traffic lanes and onto the sealed section of Yeriminup Road.

The friction of the road pavement may have been reduced due to the presence of loose material.

**Finding 2.7 Loose aggregate at intersection**

Loose aggregate should be cleared from the travel lanes and resealing undertaken to prevent aggregate build up reoccurring
