## Application to Clear Native Vegetation – Supporting Information Lot 24 Koojyanup Road, Frankland River WA

Bio Diverse Solutions has been engaged by Nigel Rowe (the applicant) to prepare a letter of support for a clearing permit application (CPS 9134/1) at Lot 24 Koojyanup Road, Frankland River (here in referred to as the Subject Site). The client submitted a clearing permit application for the Subject Site which was received by the Department of Water and Environmental Regulation (DWER) on the 3<sup>rd</sup> December 2020.

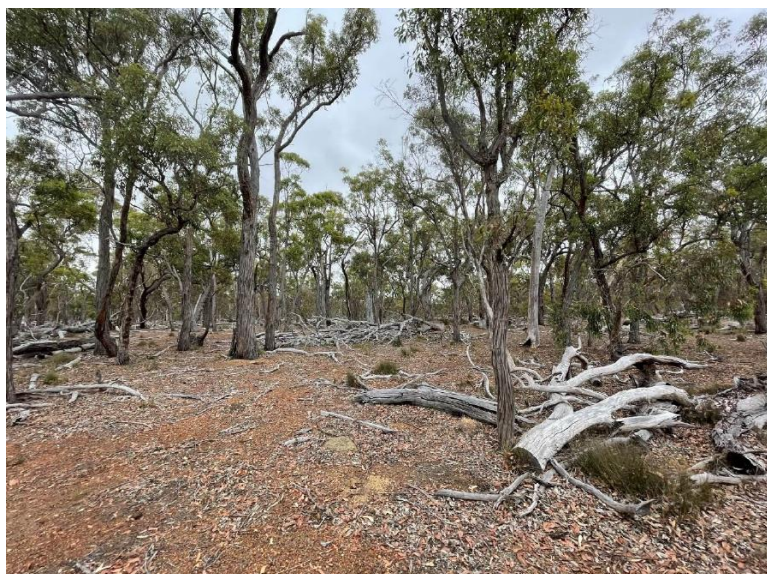
**Photograph 1: Vegetation on site, a sparse woodland with no mid-story or understorey.**

Photographs from the Land Assessment Report (DPIRD, 2021) show the Subject Site comprises of a mallee-woodland of jarrah, marri and wandoo. The trees in the woodland are sparse with no understorey or midstory. It is understood that the site was previously cleared for timber milling and few older trees (with trunk diameters <500mm) remain. The area has also historically been used for livestock grazing. Photographs of the vegetation are shown below.

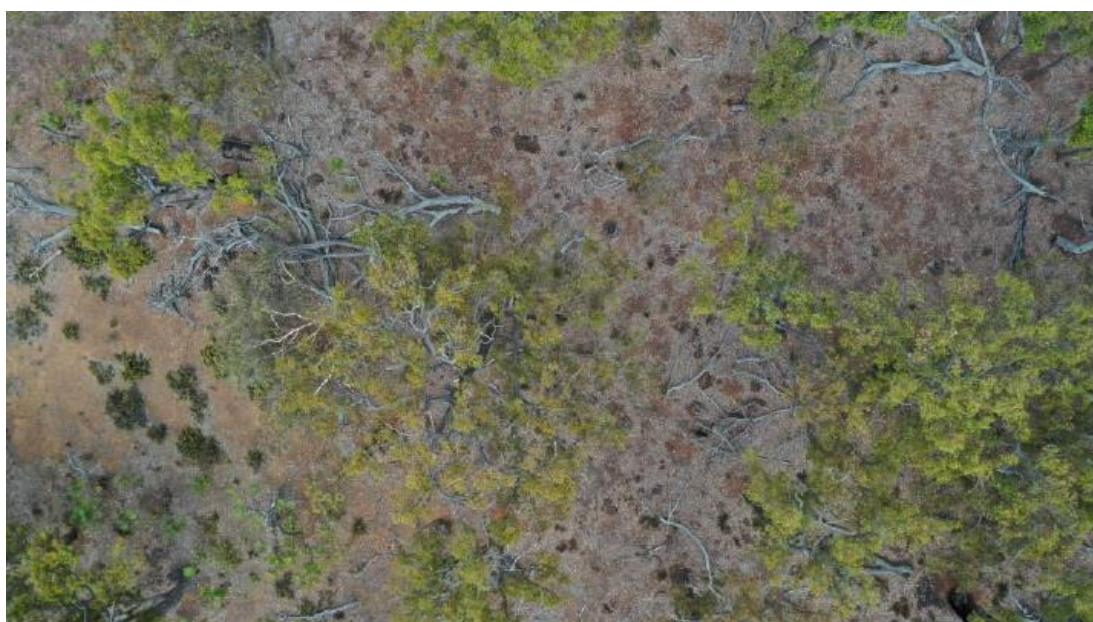
**Photograph 2: Aerial view of site vegetation, showing sparse woodland.**
